Elevation and Bathymetric survey measurements around Burden Lake.

by Larry McKeough

in conjunction with The Burden Lake Preservation Cooperation

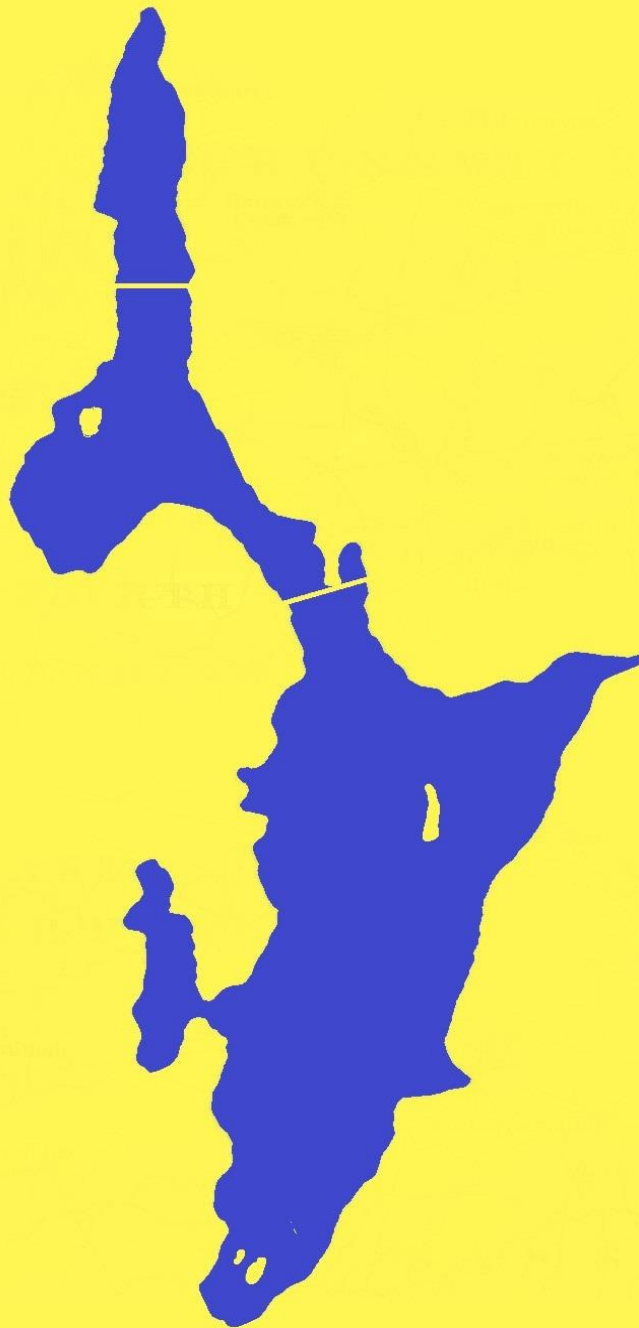
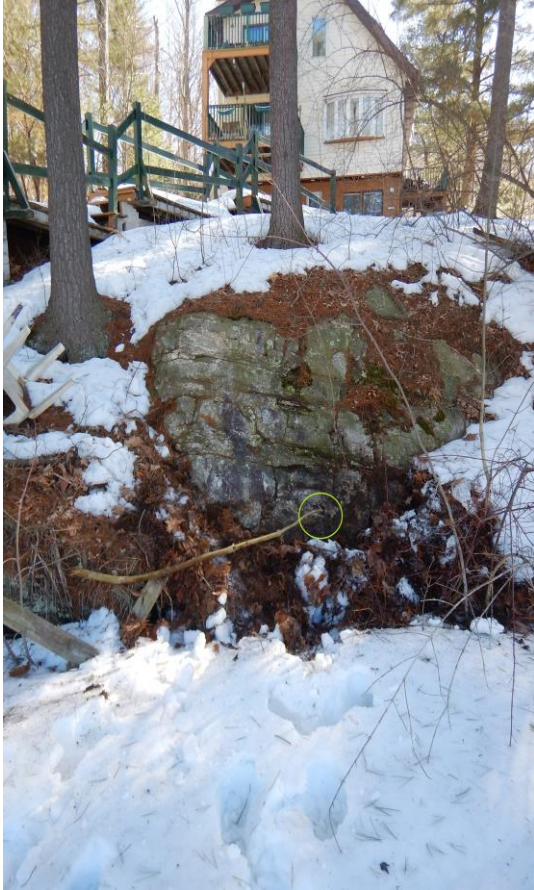
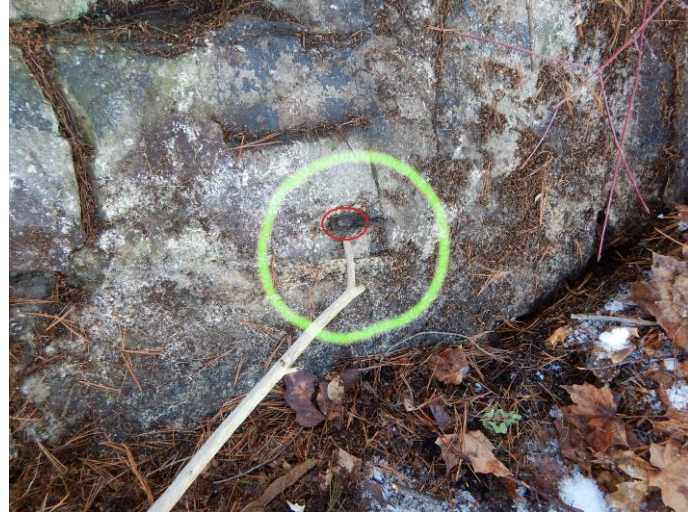
These photos show the location of the “PIN”, an iron bolt, that in 1863 was pounded into a hole drilled in a rock, on what is now the northeastern shore of the First Lake, set at an elevation of 629.68’. This pin was installed to protect the farmers’ fields from being overflowed by the Wynantskill Association any higher than this pin. This pin was set 8’ higher than the original 1830 pin which had been installed in another rock on the shore of Martin’s Lake on Bristol’s farm. (now somewhere 6’ under water in the Third Lake)

This pin marks the highwater mark of all three Burden Lakes and represents the extent of the property currently owned by the Burden Lake Preservation Corp., which owns the bottoms of the lakes up to the high-water mark, as well as the property around the dam system.

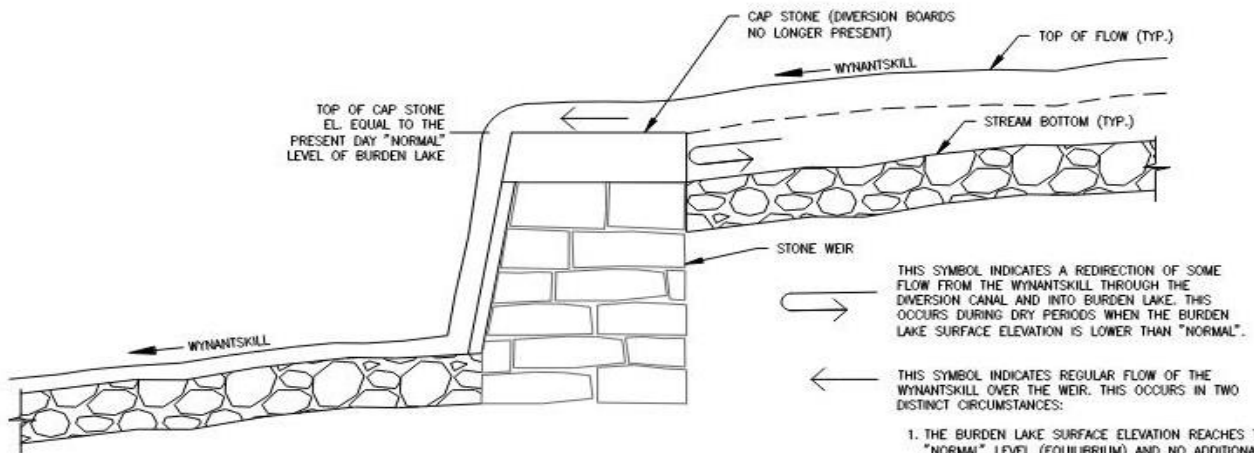
CURRENT WEIR OPERATION

- NOTES:
1. CURRENTLY THE WEIR IS SIGNIFICANTLY DAMAGED WITH TEMPORARY SAND BAGS IN PLACE TO HELP MAINTAIN THE LAKES "NORMAL" ELEVATION.
