The valve that helped start the Industrial Revolution in America, and helped to win the Civil War

By Wayne L. Pratt

History of the Valve, and Valve Guard Shack on Burden Lake

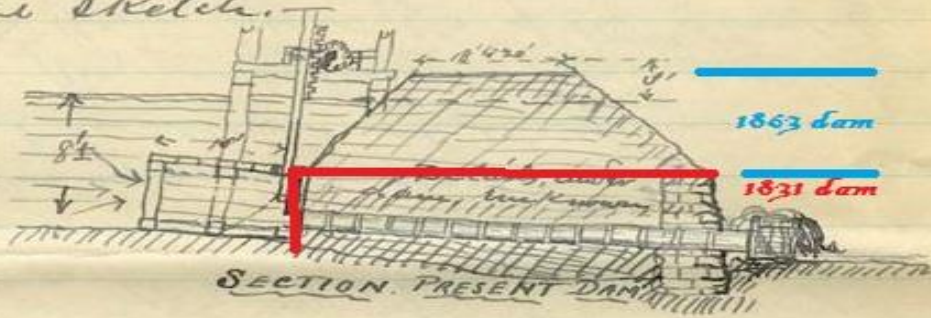
The section of this dam, through the trunk and gate is about as shown in the sketch.

Green's 1889 drawing which shows a cross section of the Dam at that time. Drawing shows the original slide type Valve and wooden pipe.

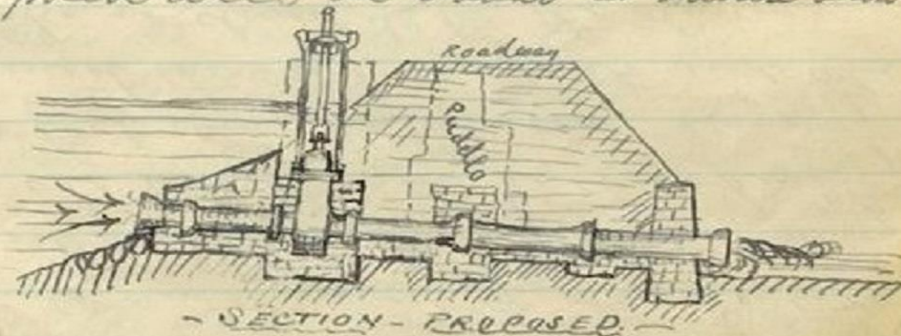
The section of the dam, with the pipe, of iron, as proposed will be about as shown below.

Green's 1889 drawing of the recommended replacement with "New Style" Cast iron pipe & Gate Valve, installed shortly thereafter.

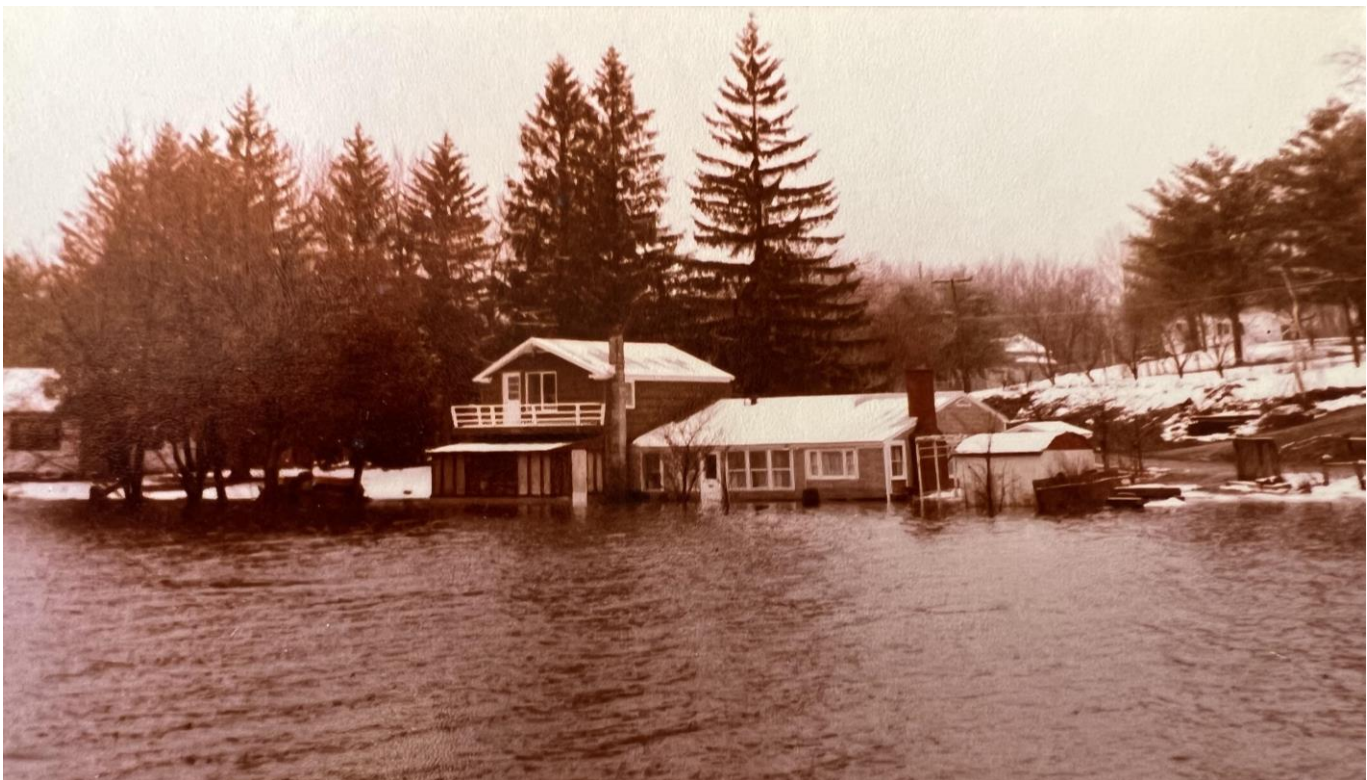
Photo courtesy of Vinny Robelotto

Photo shows Robelotto's camp (on 3rd. Lake near Kays) flooding in the mid 70's

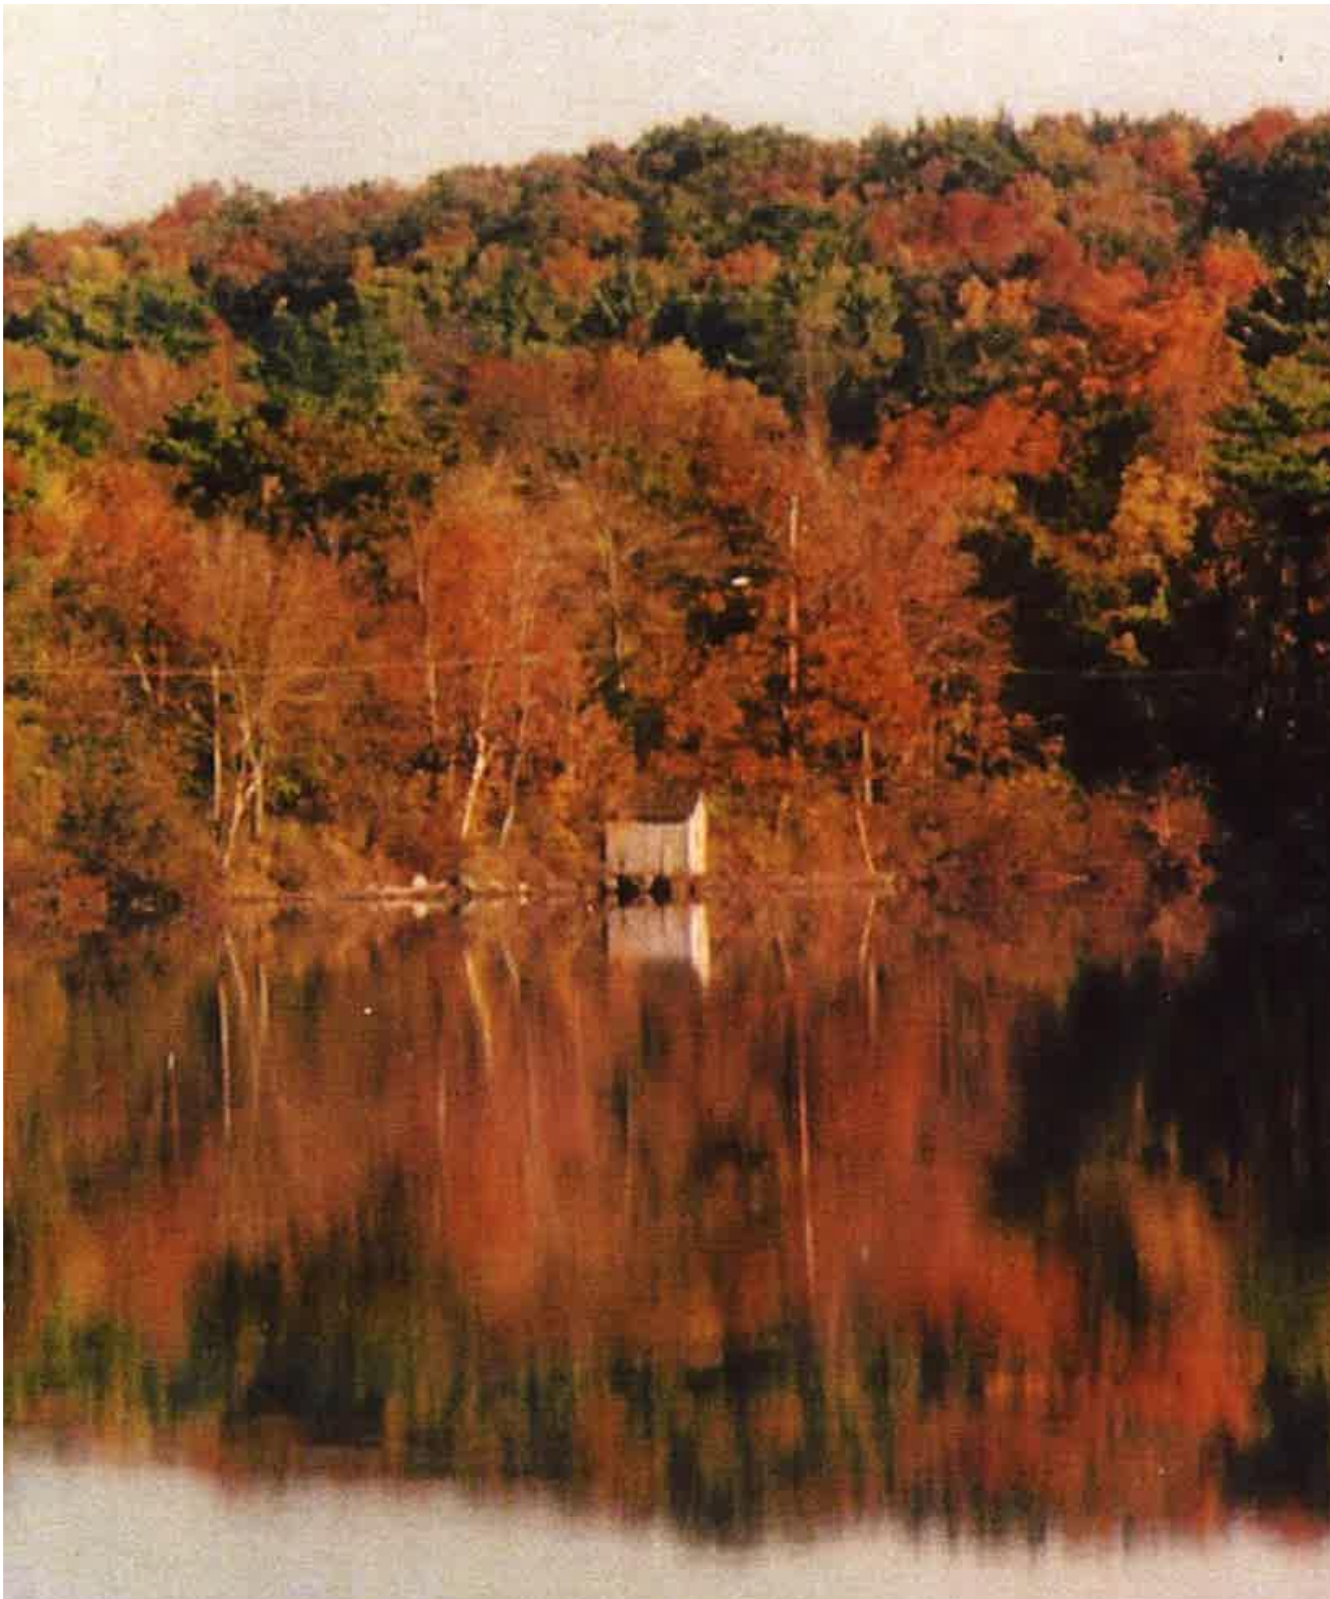
Photo courtesy of Sean Baldwin

We think the demise of the shack and Valve was caused by snowplows.

Since 1948, when the County widened the Dam, the shack was very close to the edge of the road. For about 40 years snowplows heading north towards Averill Park, traveling at 30 MPH most likely pushed snow against the Shack. Especially during large snow falls. Wet, heavy snow would have been the major contributor from the throwing force of the snow at the front of the shed.

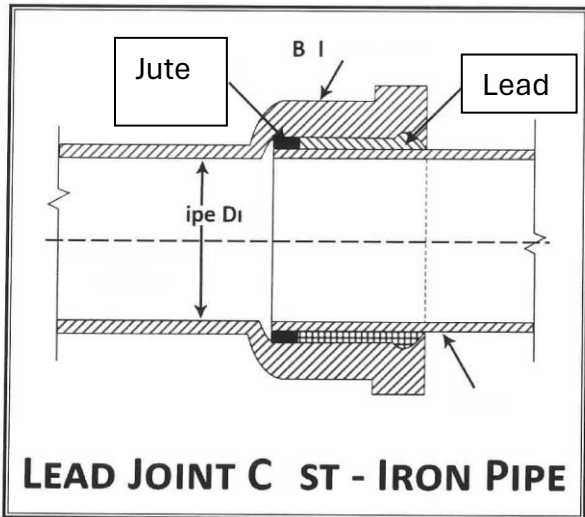
Diagram shows the method of joining two cast iron pipes. While this joint formed a leak proof seal, it was not mechanically strong. That is why the pipes were supported and sometimes surrounded with a masonry base. Rember, these are 30" diameter cast iron pipes.

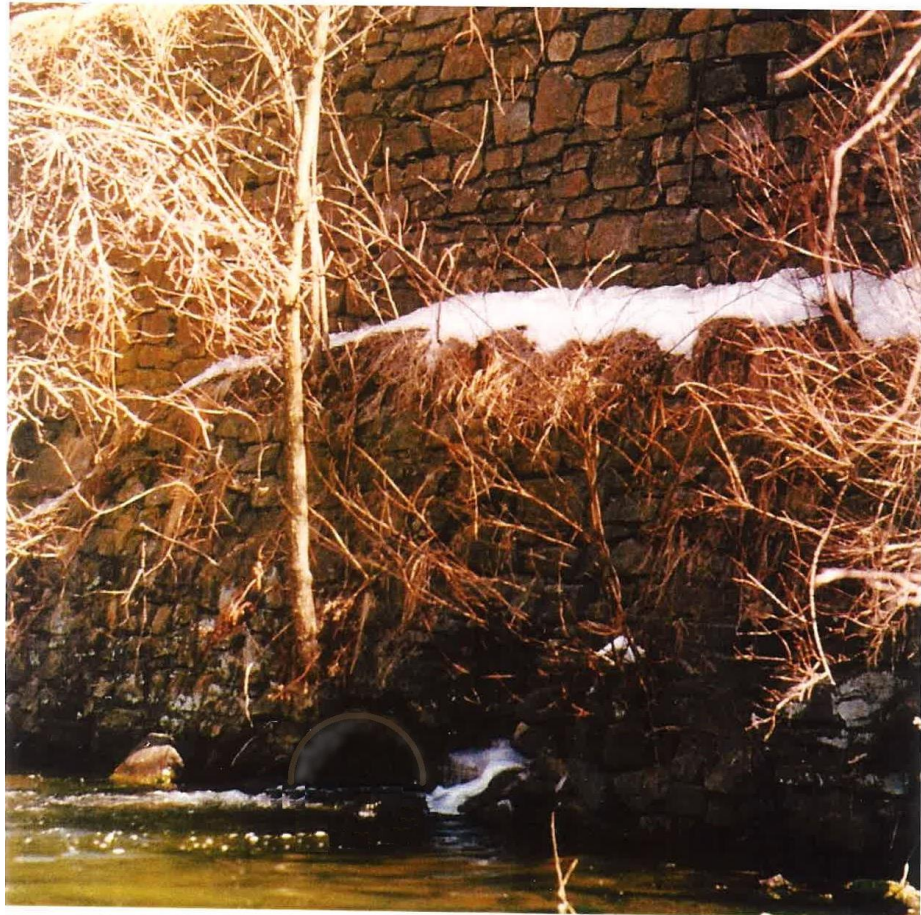
Picture shows outlet pipe before the cap was installed with water discharging from the pipe.

A small group of concerned Burden Lakers¹ got together and came up with a plan. They made a cover plate and collars which could be bolted over the flange on the outlet (west) side of the pipe. The cover plate had 24 bolt holes drilled in it. They used long pieces of threaded rod and a gasket and gradually drew the cover plate up against the flange. This successfully stopped the leak and is still in place today.

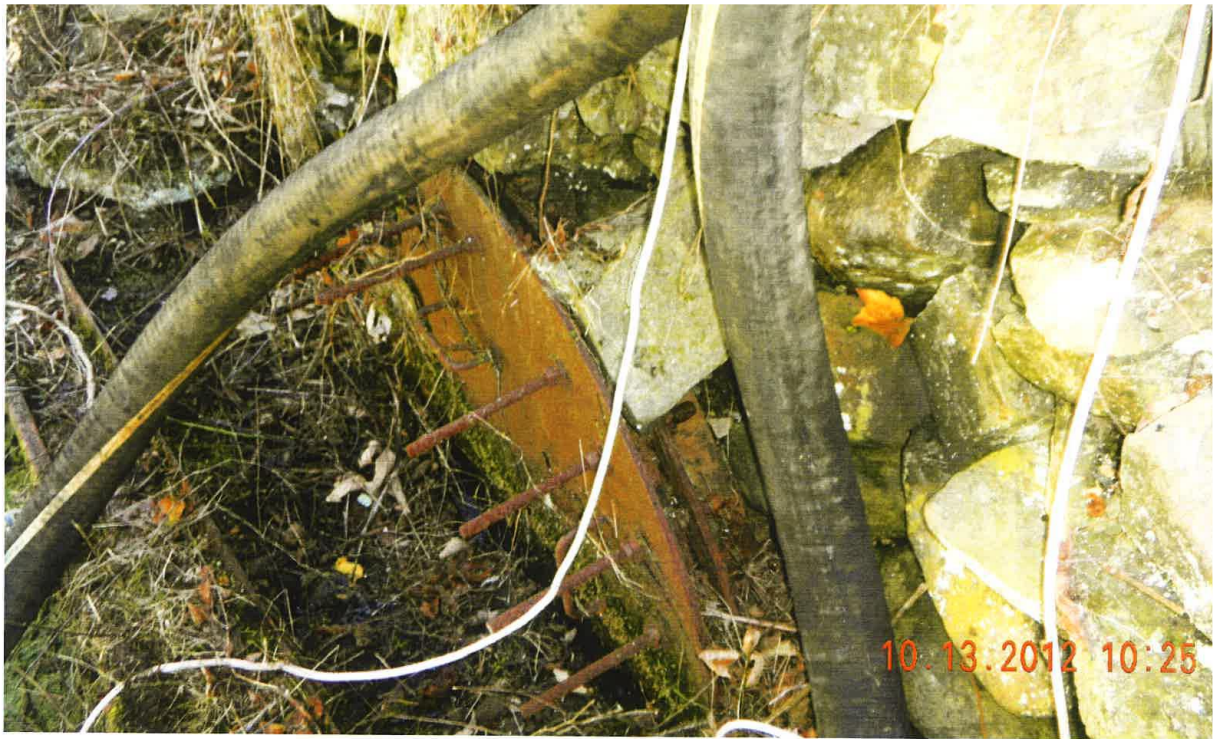
Picture shows cap installed on the outlet pipe.

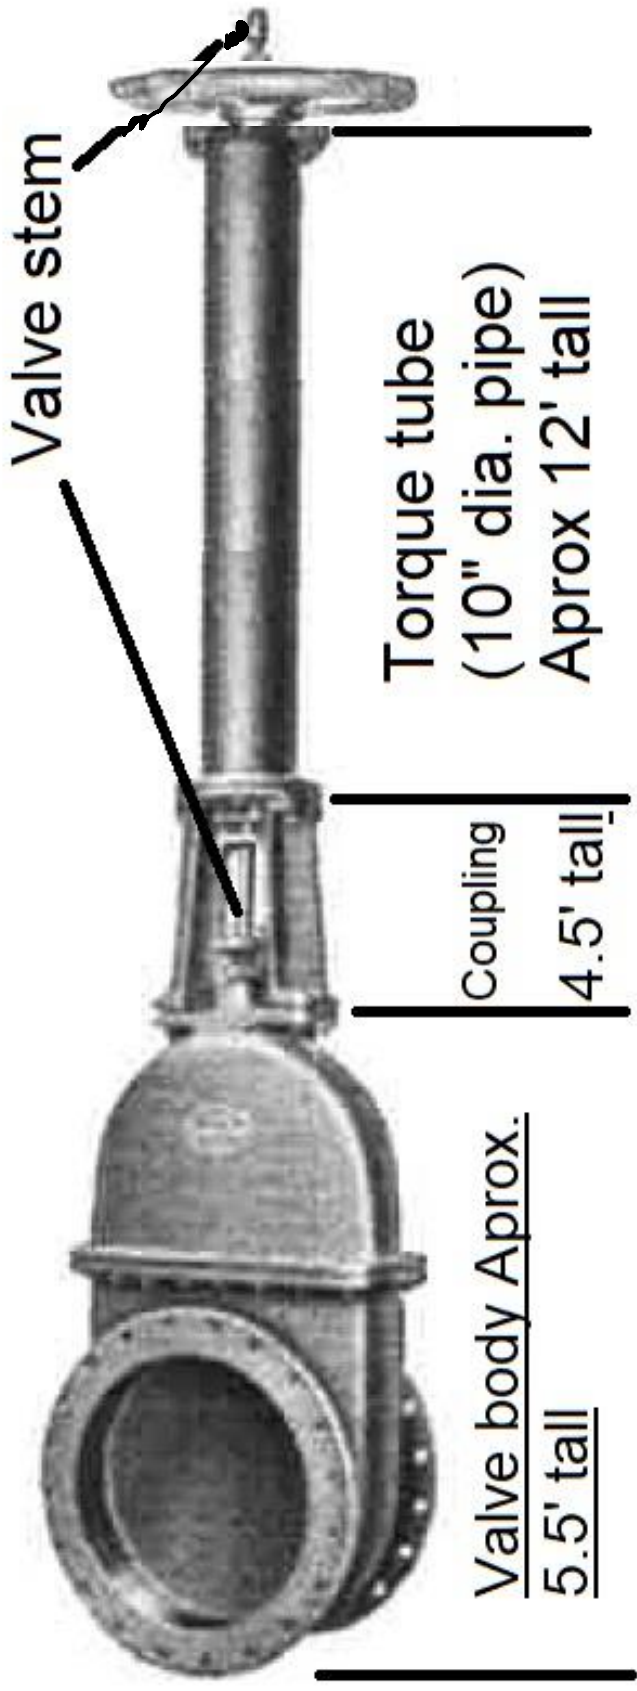
Here is a Ludlow gate valve from the same era. It shows a 12' valve extension. The part that looks like a pipe at the top is the torque tube. The valve stem is inside the torque tube. This is what appears to have separated from the valve body which we attempted to bring to shore.

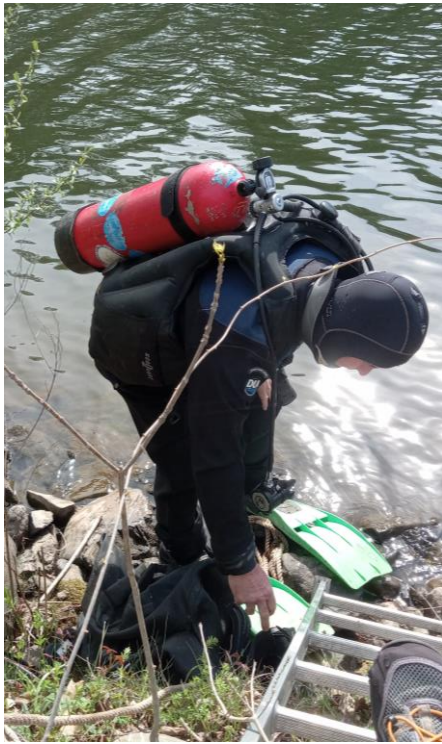
Tim VanDuesen

On 5/4/24, the BLPC hired a scuba diver to go into the First Lake to find the valve stem and whatever else could be seen. Scuba diver, Tim VanDuesen, entered the water at about 9:30 am. He found the valve, with wheel intact, about 20 feet from shore in 10' of water. He could not locate the inlet pipe and thinks it silted in. The torque tube and valve stem were not attached to the valve body. They did not appear to be broken; the bottom of the torque tube was smooth as if it simply came out of a slide coupling. There were two ropes already tied to the wheel. (from when Mr. X. tried to lift it with the tow truck) We attempted to bring the torque tube, complete with valve stem and wheel, closer to shore. We connected a chain and come-along between the wheel and a good size tree on shore. Try as we did, (we could move it some but), it refused to come into shore so we could examine it.

Pictures from the dive.

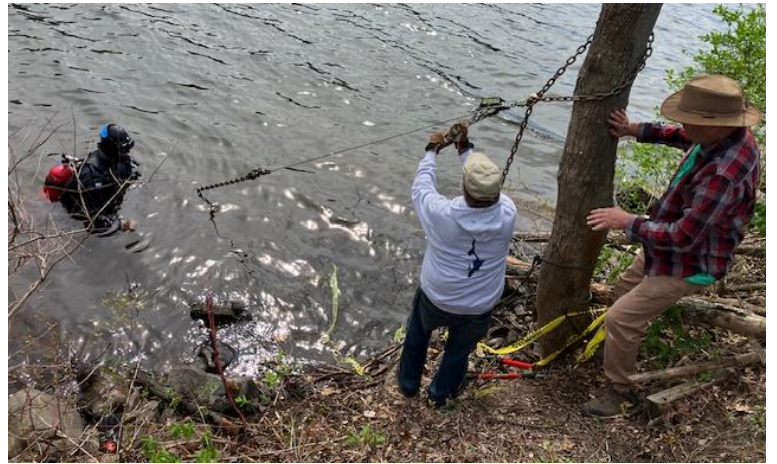
Tim VanDuesen in water, Larry McKeough & Paul Ashline trying (unsuccessfully) to pull the valve extension stem up to shore.
Photo- Wayne Pratt

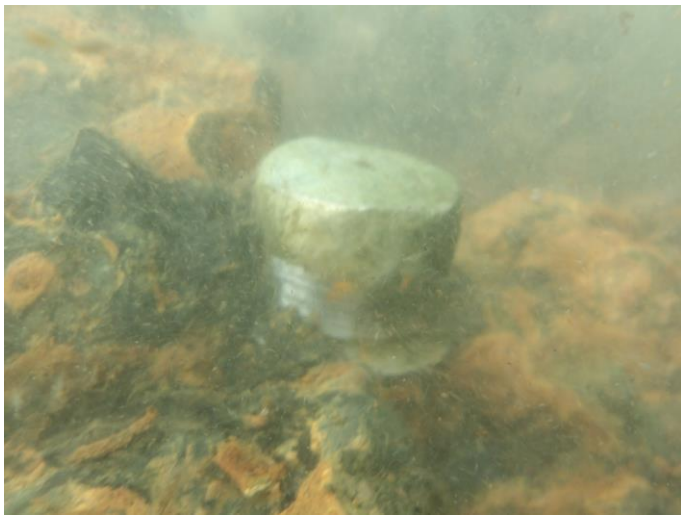
Underwater photo we believe of the valve stem top protruding through the operating wheel.

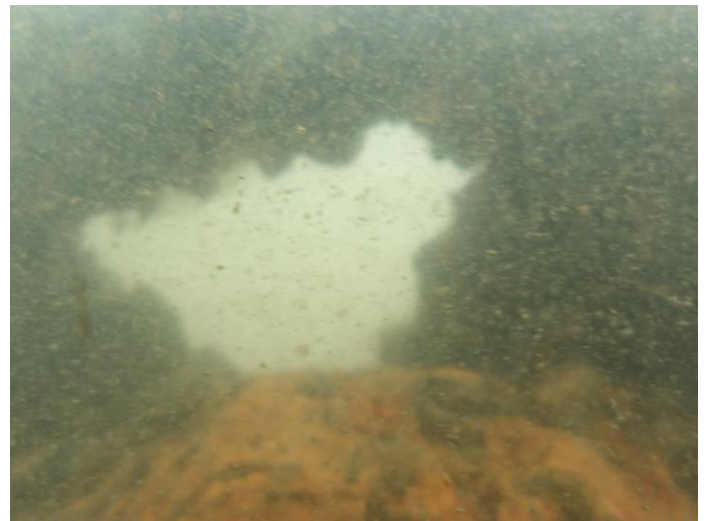
Underwater photo we believe looking through two of the operating wheel's spokes.
