Elevation and Bathymetric survey measurements around Burden Lake.

by Larry McKeough

in conjunction with The Burden Lake Preservation Cooperation

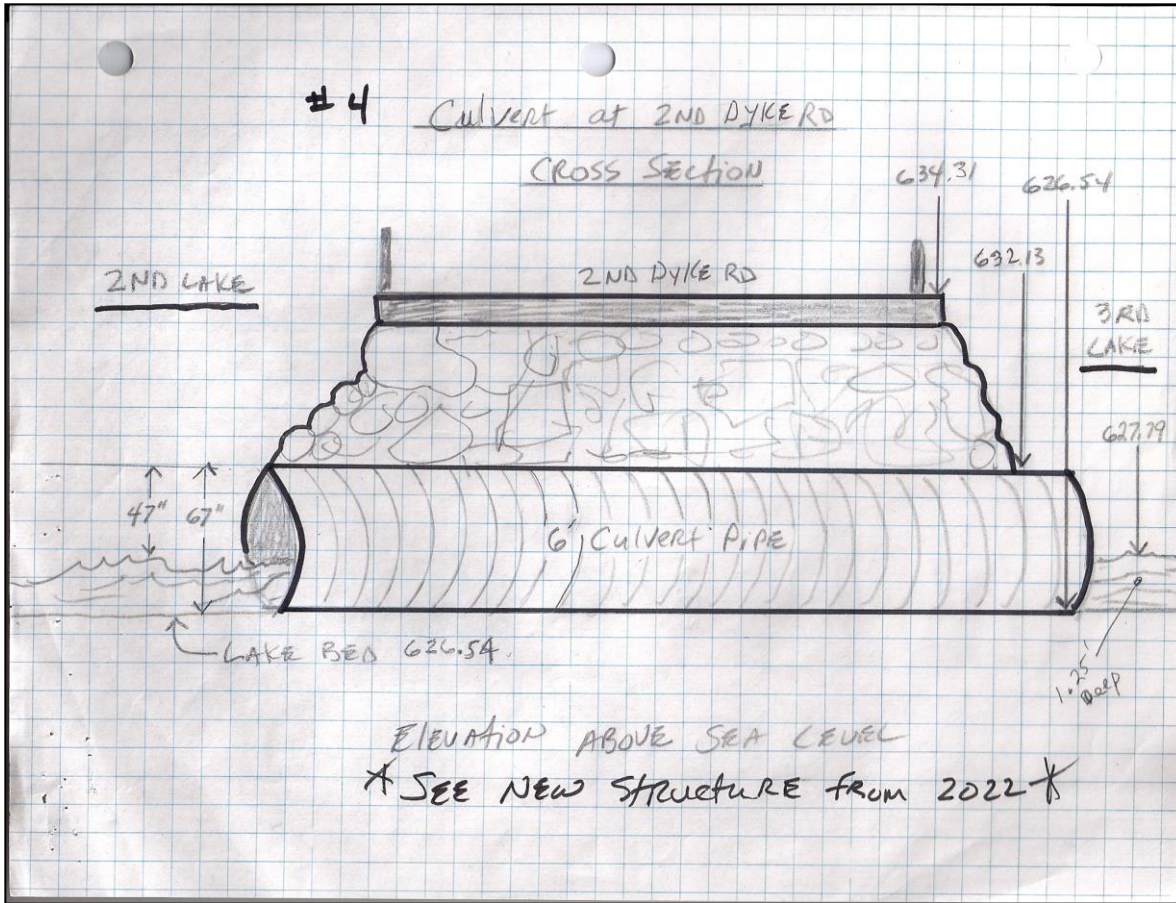
**#4 – Culvert Pipe under Second Dyke Road
circa 2021. This was replaced in 2022/23**

The culvert in the 2nd Dyke Road (Sketch #4) - the road surface is 634.31' above sea level. The top of the culvert is set at 632.13 above sea level. The lakebed in the bottom of the culvert is 626.54' above sea level. The culvert is a 6' (now egg shaped) culvert and there is 67" from the gravel in the bottom of the culvert to inside top of the culvert. This culvert was replaced in 2022 with a modular concrete structure which was supposedly set to the same elevations as the culvert pipe it replaced.

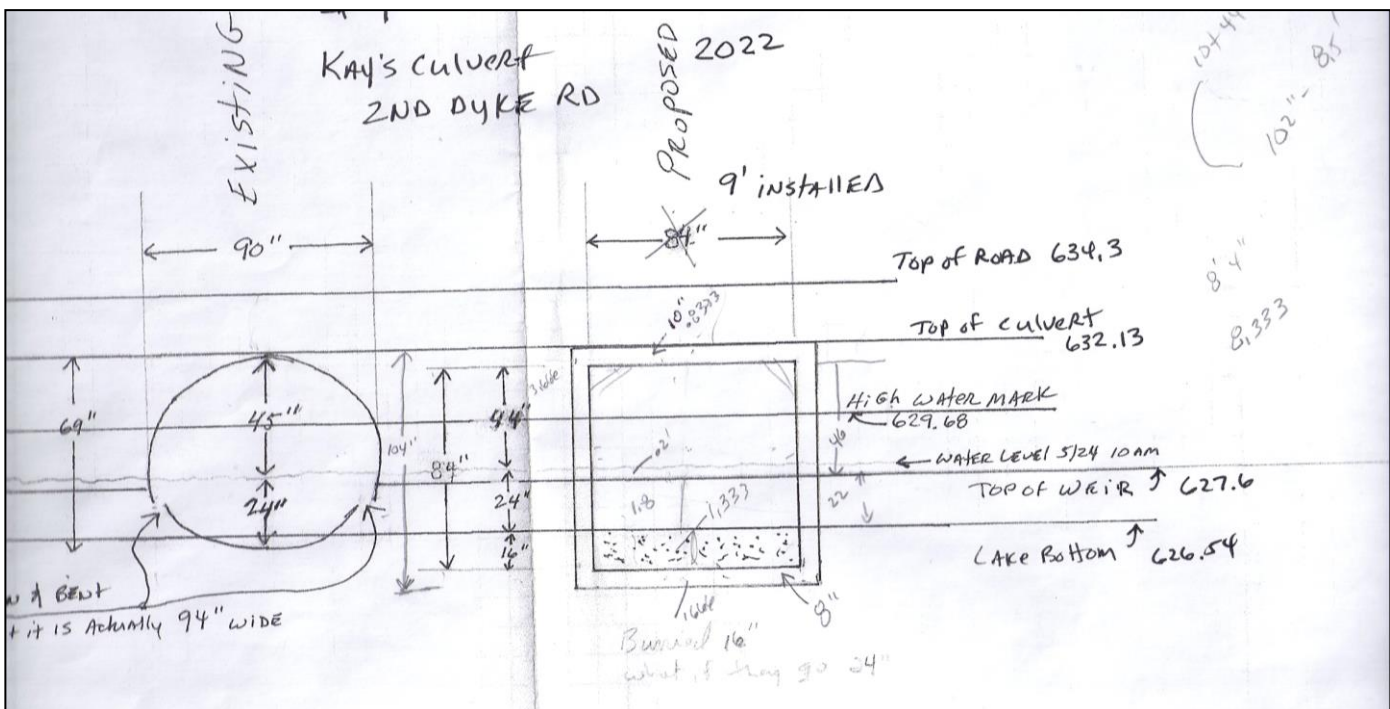
Comparing old culvert pipe with proposed replacement

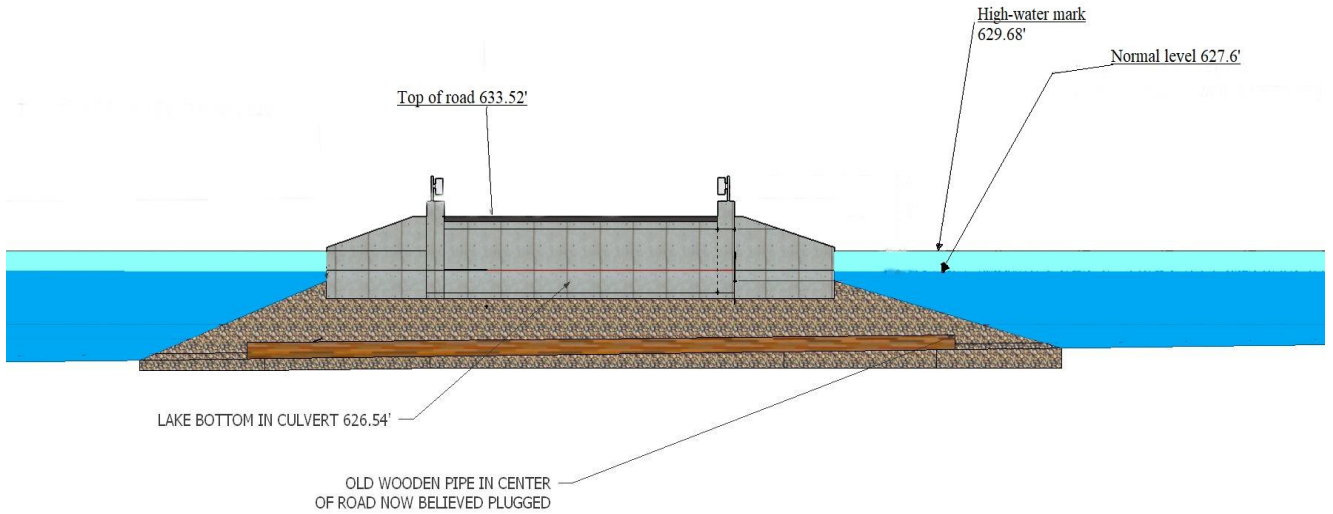
#4- Second Dyke Road
New concrete structure installed 2022/2023

Cross section of new culvert at 2nd. Dyke installed 2022-2023

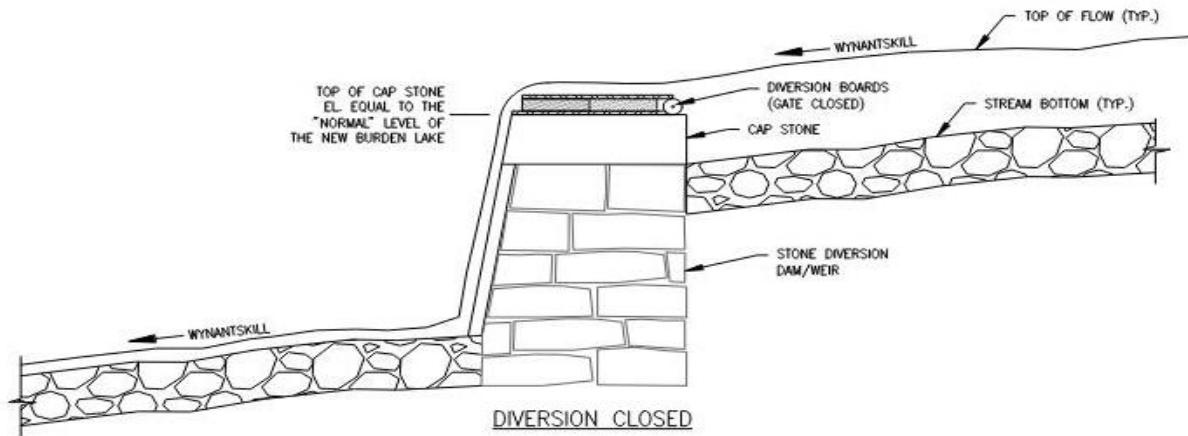
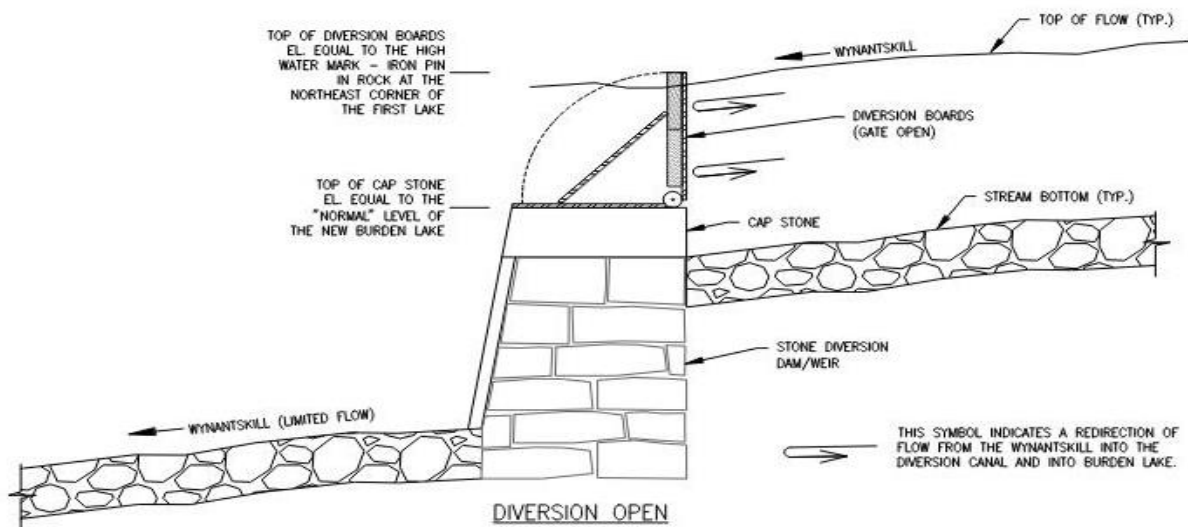
HISTORIC DIVERSION DAM/WEIR OPERATION

- NOTES:
1. CURRENTLY THE WEIR IS SIGNIFICANTLY DAMAGED WITH TEMPORARY SAND BAGS IN PLACE TO HELP MAINTAIN THE LAKES "NORMAL" ELEVATION.
